Case 260 : Narrative

Case Vehicle (A): 1998 Oldsmobile
Type: Intrigue, 4-door sedan
Driver: 48-year-old male
CDC: 12-FDEW-2

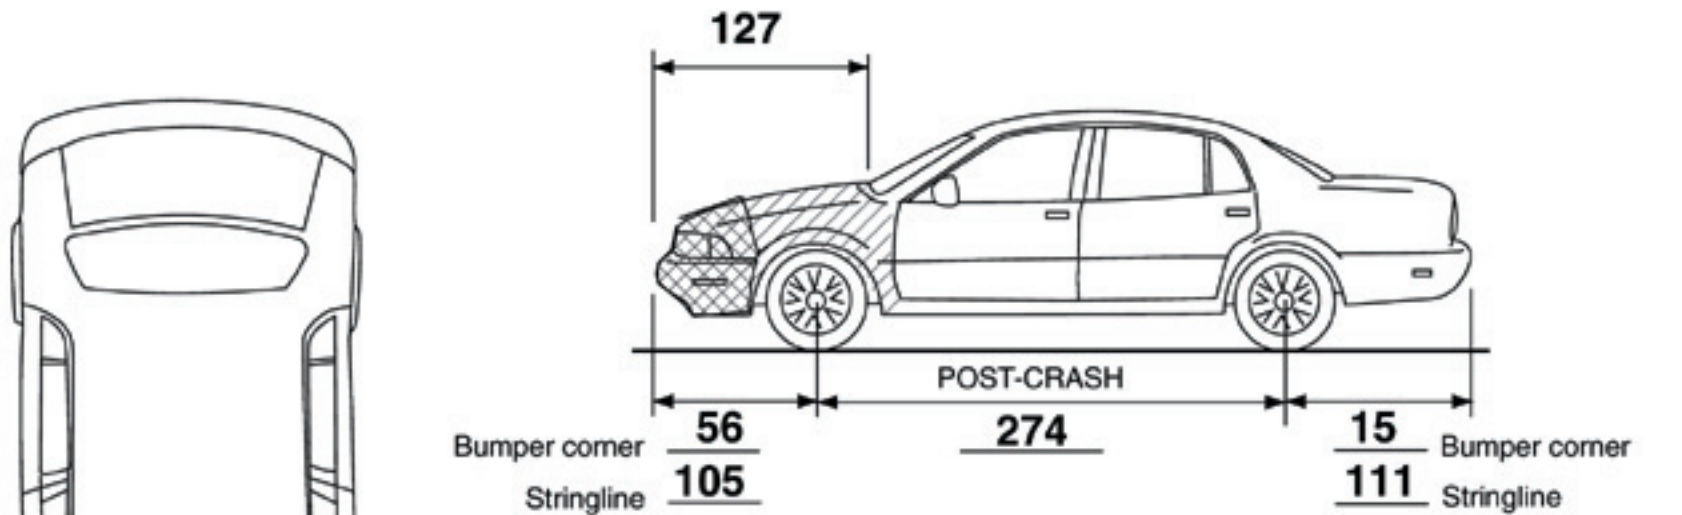
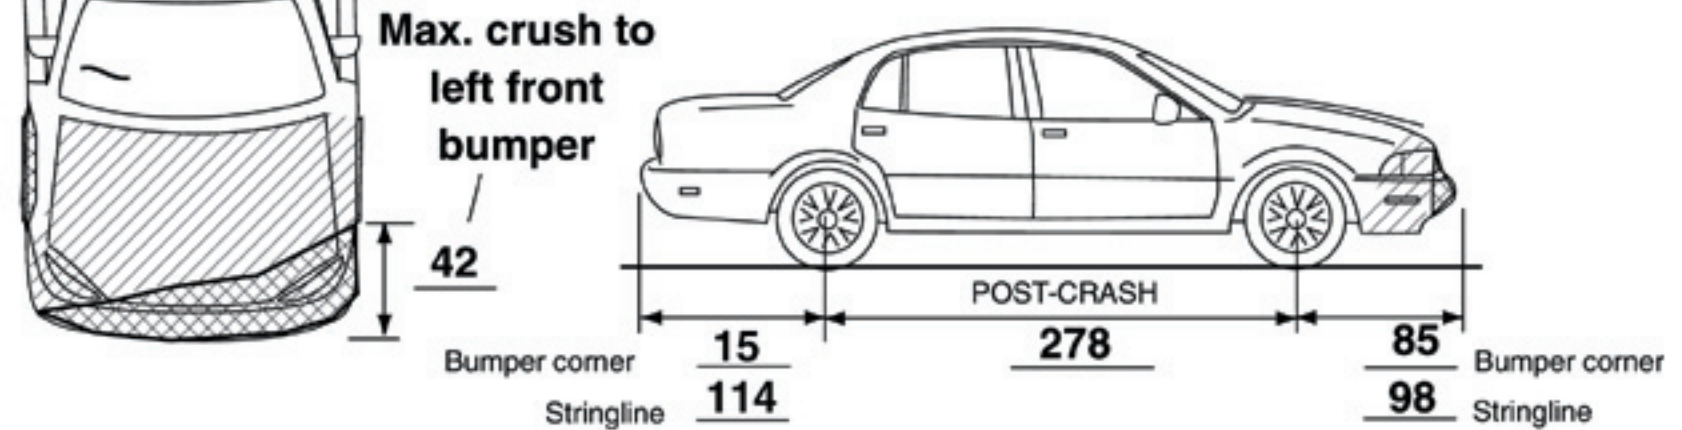
Front stringline is 8 cm short

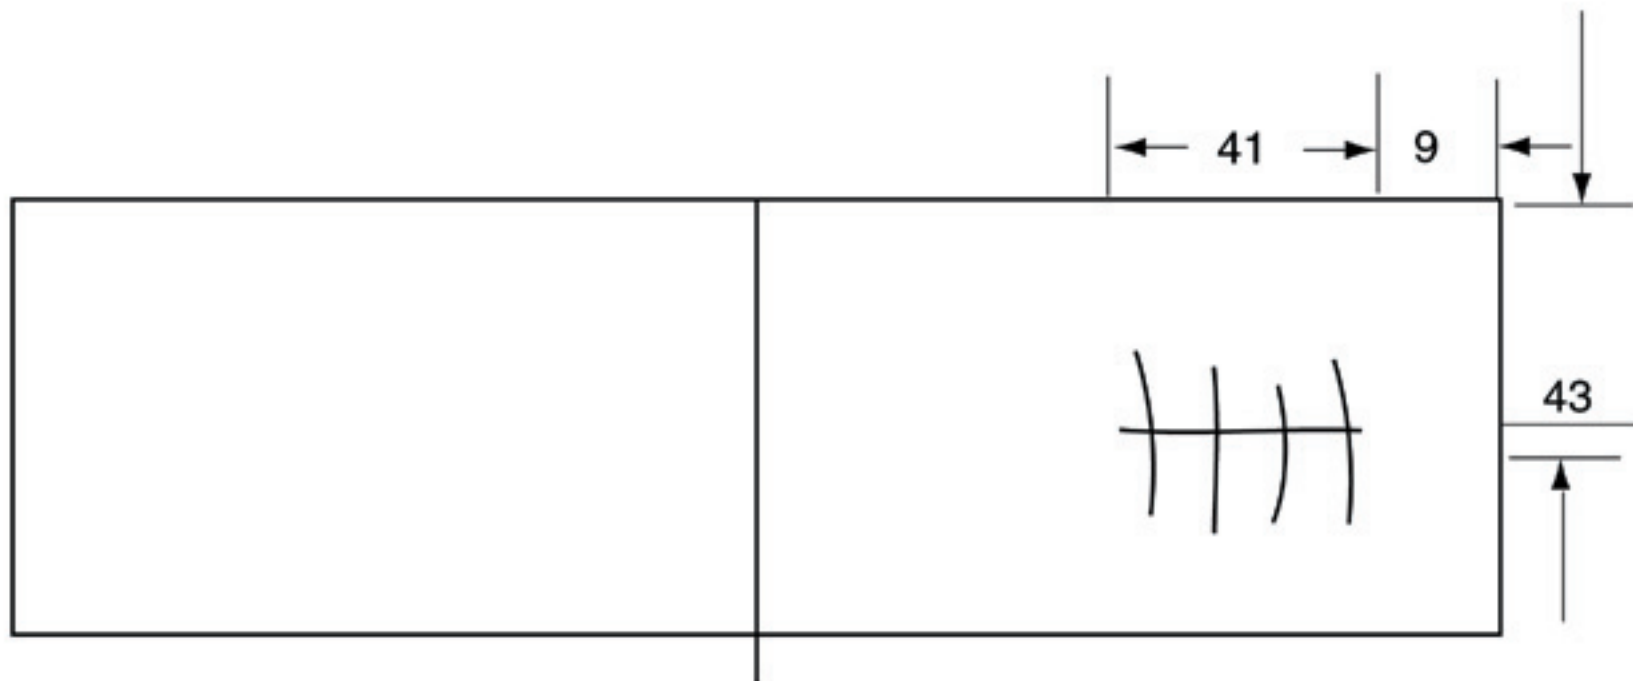
cracked due to passenger airbag flap contact

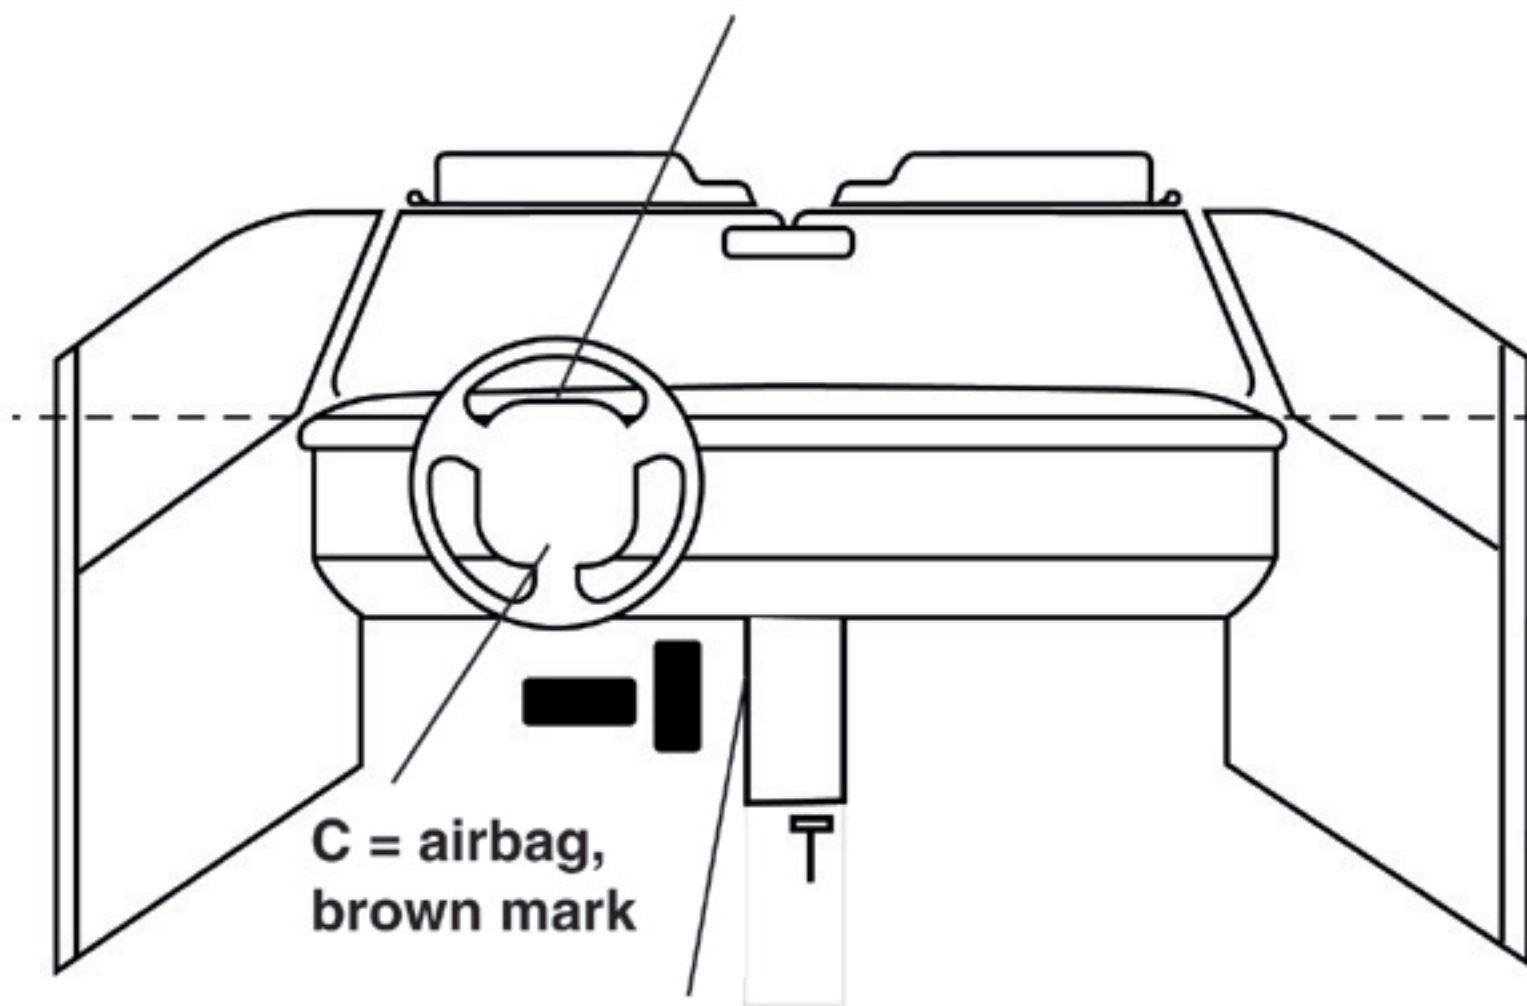
**B = airbag,
black mark**

**C = airbag,
brown mark**

**A = vertical console,
broken plastic and
scuff mark**
